# The restoration of the cathedral at Kirkjubøur in the Faroe Islands

Poul Klenz Larsen , Thorborg von Konow and Sölve Johansson

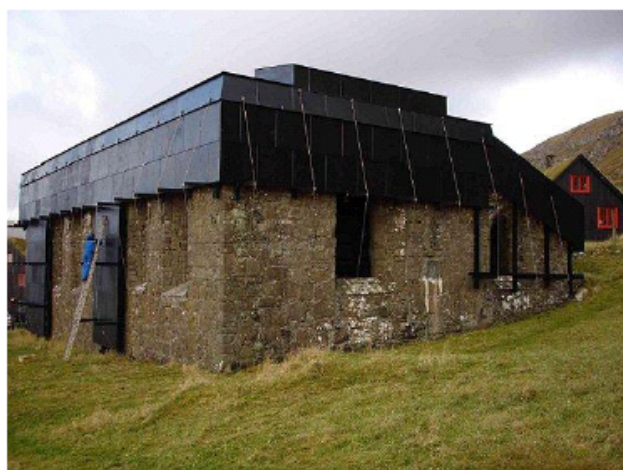
The walls of the monument are approximately 9 m high and 1.6 m wide at ground level (fig.1). The arches for the windows and porches are constructed of regular blocks with even joints. In contrast, the walls in between consist of basalt boulders in various sizes and shapes, collected from the hillside next to the site (fig. 2). The cavities between the boulders are filled with smaller pieces of rock and mortar. Two core drillings in the south wall confirmed that the inside has solid mortar infill too. The mortar inside the wall is rather hard and good adhesion to the basalt. It is a substantial part of the construction and serves a structural purpose. Once hardened the mortar infill transfer the vertical load from one block to the next, so the stress is evenly distributed over the cross section. But even more important is the ability to transfer the horizontal load from the vaults, which were supported by the walls 5 m above ground.

Fig. 1 The ruin of the cathedral in Kirkjubøur is located at the foot of the hill facing south to the Atlantic Ocean. The temporary shelter protects against the very humid and saline environment.

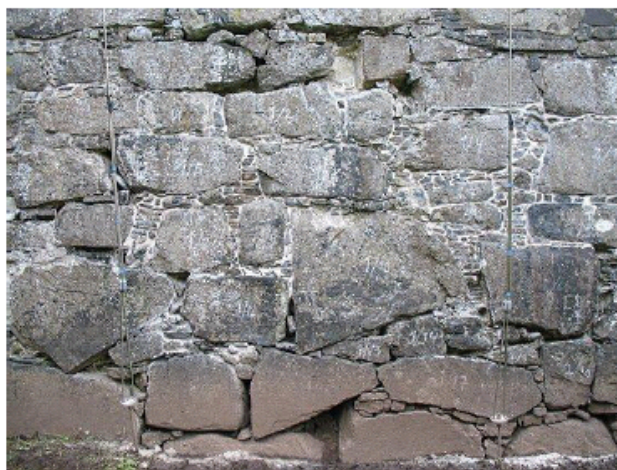
Fig. 2 The walls of the cathedral is made of irregular basalt boulders. The cavities in between are filled with smaller pieces of rock held in place by the mortar. Test area for restoration on the north side of the north wall.

In the summer 2007 three test areas were established on the north side of the north wall (fig. 2). Each area is approximately 2.0 x 2.0 m, located 1 m above ground level. The facade is little exposed to wind and sun, so this part of the monument is protected against the natural drying and wetting cycles. One mortar was made with lime and aggregate slaked together. One mortar was made with lime putty matured for 3 years, mixed with a pozzolan (Metastar, see below) to gain an early setting of the mortar. A premixed hydraulic lime mortar NHL3,5 was also tested. During the

first winter lime was leaking from the joints made with the pozzolanic lime mortar, whereas the hydraulic lime mortar remained unaltered.

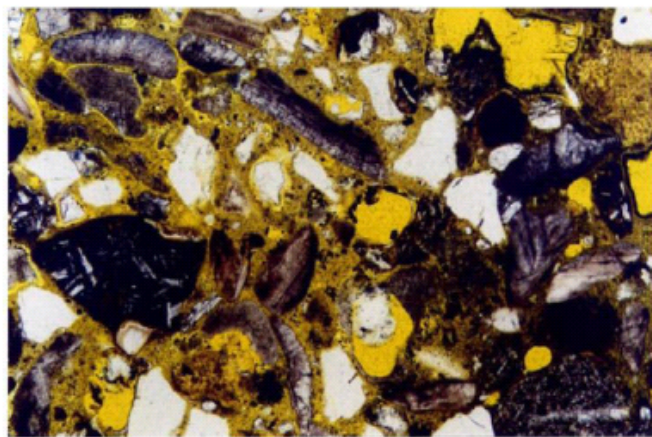
the composition (fig. 3). All samples have rather similar volumetric composition and structure. The pores are mainly round and separate, sometimes connected by fissures, in average 15% by volume. In some samples the pore volume is partly filled with crystals of precipitated lime, an evidence of the extreme humid environment. The silicate aggregate makes up 27% of the total volume. It is a mixture of white, rectangular quartz grains and black, round grains of basalt. The aggregate is similar to the natural sand deposits at the beach nearby the monument.

The average lime content is 41%, and there is an additional 18% fraction of unfired seashell and lime inclusions. The presence of shell fragments indicates that the shells were also used for the lime binder. The dark brown areas within the lime matrix might be unfired fragments of the shells, or a hydraulic silicate component (fig. 4). Such minerals do not come from the shells themselves, but may derive from silicate particles mixed with the shells, or deliberately added prior to firing. The hydraulic minerals would evolve during the firing process as in a natural hydraulic lime. The silicate particles may also have been mixed into the lime before slaking or even after slaking to act as a pozzolan.

Fig. 3 Thin section of the original mortar in sample 12. The black grains are basalt, the white grains are quartz, the light brown matrix is lime and the grey particles are shell fragments. Yellow areas are pores. The total area is approximately 7 mm<sup>2</sup>. Photo by Thorborg von Konow

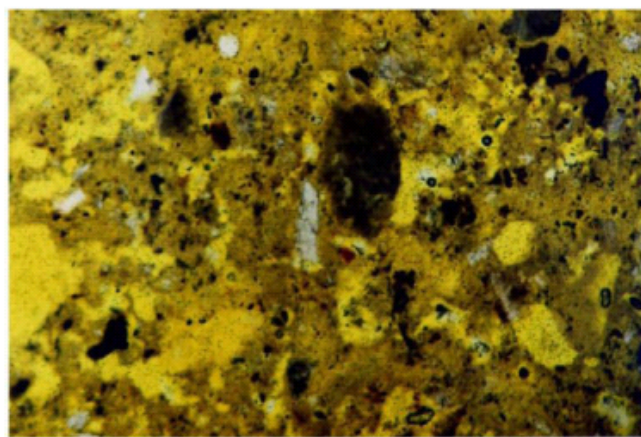
Fig. 4 Thin section of the original mortar. Detail of the lime matrix. The dark brown areas are possibly hydraulic minerals. The total area is approximately 1,2 mm<sup>2</sup>. Photo by Thorborg von Konow

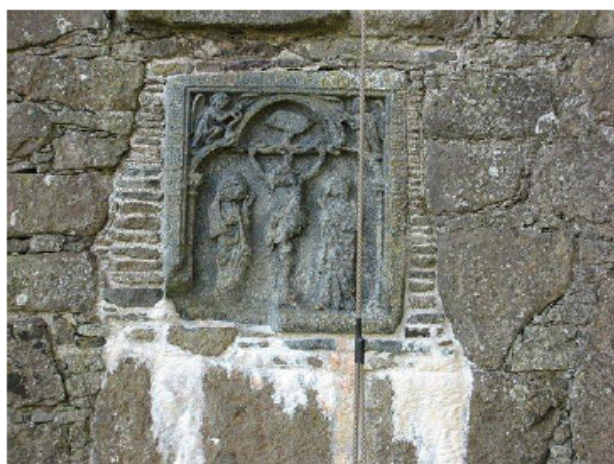
Fig. 5 The lime deposit below the relief on the east wall has leached from the lime mortar used for the joints.

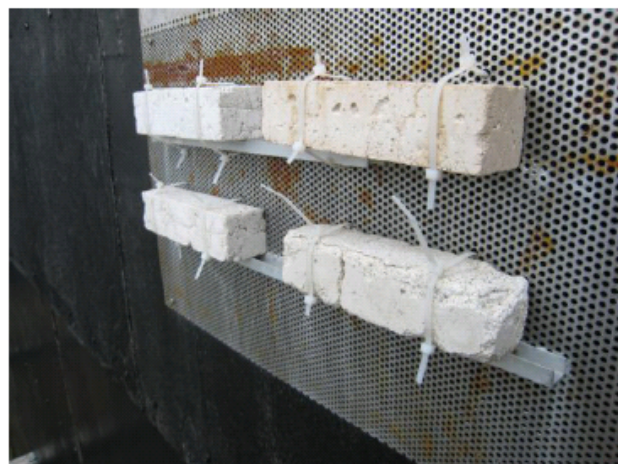
Fig. 6 Test samples was mounted on the south wall to test the resistance to weathering

The compression strength was measured after two and four weeks and after half a year. Type C reached a maximum at 7 MPa already after four weeks, whereas it took 6 months for type A and B to reach maximum at 8-9 MPa. The fast hydration is a characteristic of  $C_3S$ , which is the dominant mineral in Portland cement. The slow hydration is typical for natural hydraulic lime, which mainly contain the mineral  $C_2S$  due to the lower firing temperature. The compression strength of type D was below 1.0 MPa, which is similar to a pure lime mortar, so the amount of pozzolan was probably too little to have any effect. Specimens were mounted at the south wall 6 m above ground to test the performance in the local environment (fig.6). The position was not sheltered in any way, and the specimens did not enjoy the thermal stability of the solid wall. After one year the type D mortar had suffered severe degradation and would probably fall apart during another season. The hydraulic mortars were not much affected, so it seems to be the right choice for a restoration mortar.
