# The diverse Norwegian lime mortars

Research project

Increasing the knowledge of mortars at  
medieval stone churches

*Per Storemyr, Rune Langås, Øystein Aa. Digre and Torben Seir*

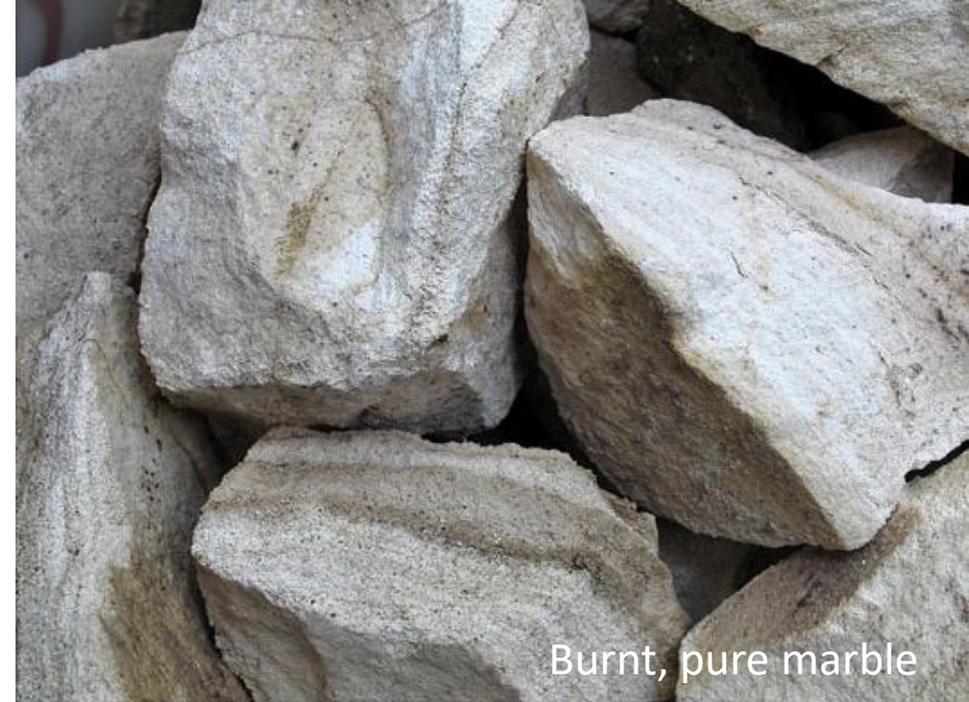
Burnt, pure marble

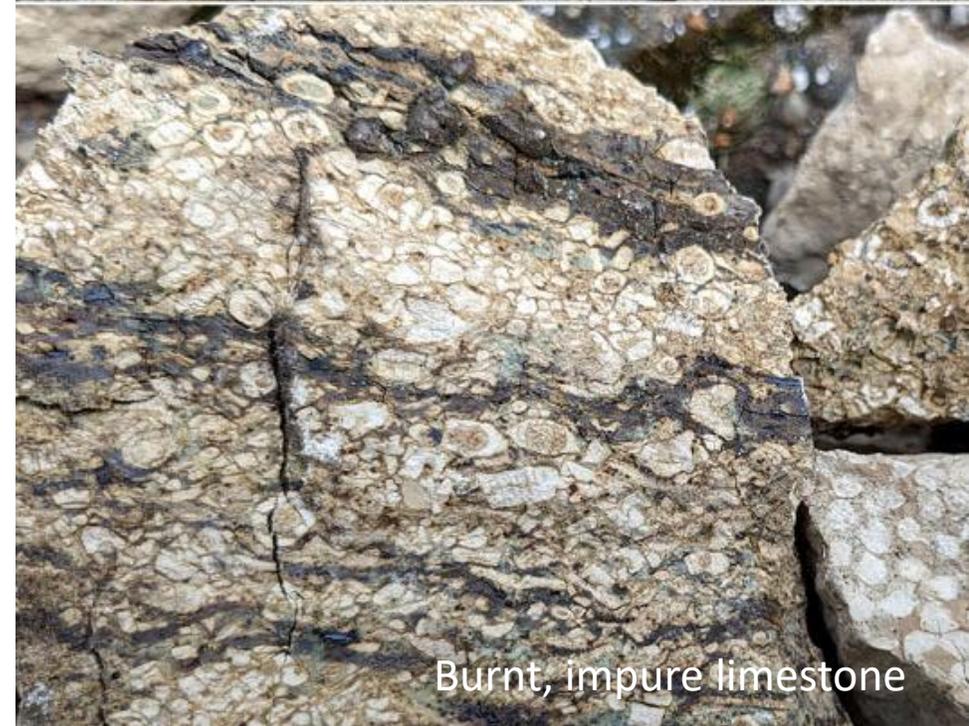
Burnt, impure limestone

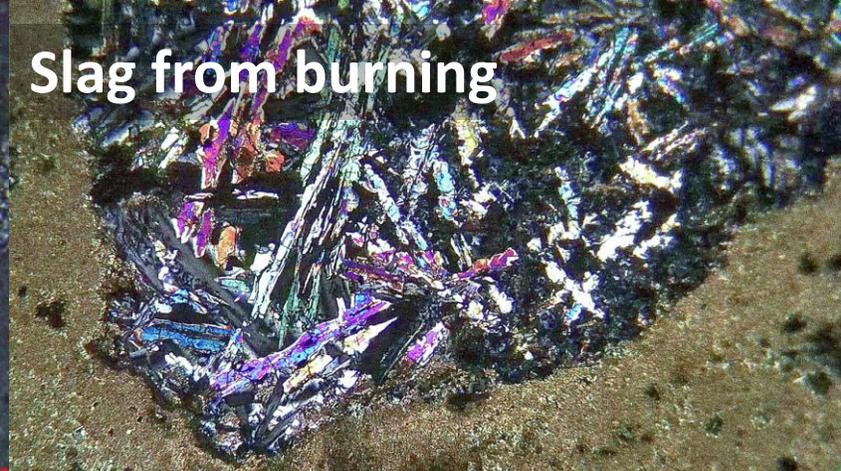
Slag from burning

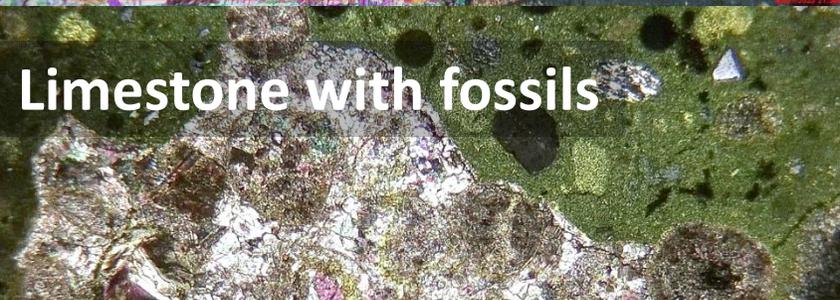
Limestone with fossils

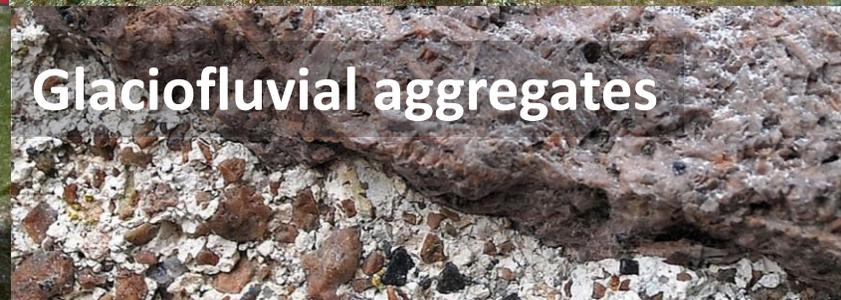
Glaciofluvial aggregates

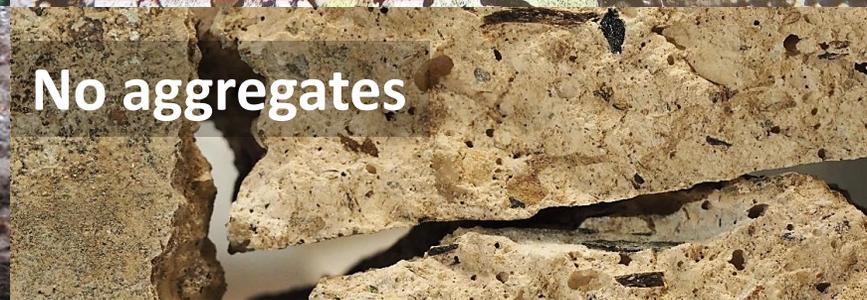
No aggregates

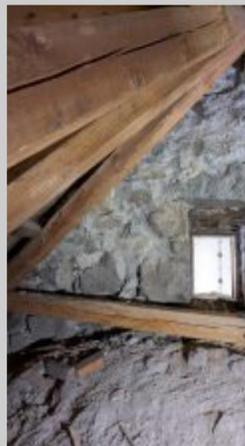
Foto som viser prøvested

Mørtel fra overkant av fuge i toppen av hvelvet i apsis

Prøvestedet er i fuge mot toppen av hvelvet

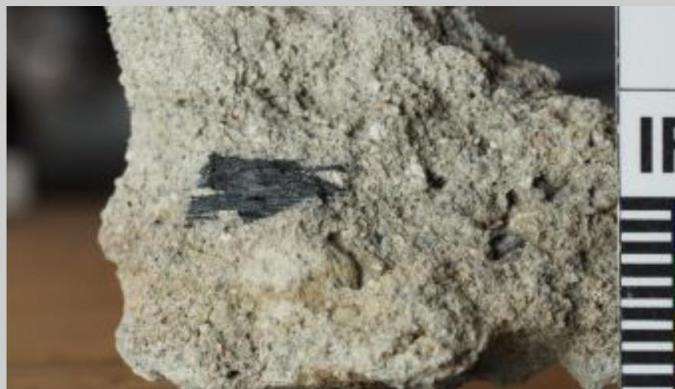
Foto av bit

Beskrivelse Lys, beige-grå, litt smuldrende mørtel, porøs, varierende størrelse tilslag, en del kullbiter, ikke godt synlige skjellfragmenter, men de kan være der. Eldste/eneste mørtel i fuge

En av flere små prøvebiter. Kullbit i midten (mm-skala)

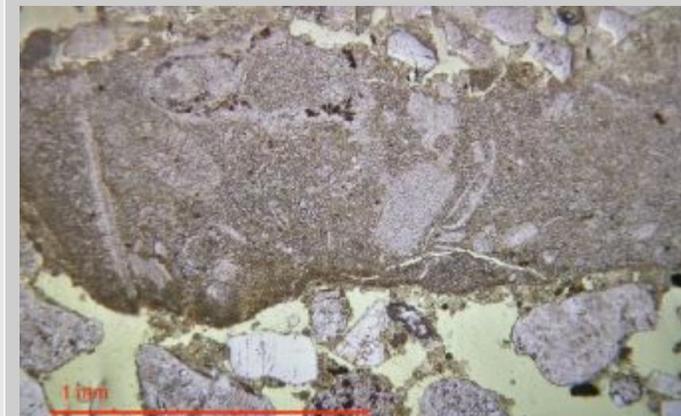
Mikrofoto

Kalkstein med en del skjellfragmenter, mulige rester av få sjølliljestilker. Sannsynlig dels kontaktmetamorf, men store kalsittkorn kan også representere sparitt. Det finnes en del små kvartskorn i kalksteinen. Kalksteinen fremstår relativt ren til tross for det ganske brungrå

Ubrent kalksteinskorn med skjellfragmenter i en mikrittisk grunnmasse. Stengelen til venstre kan være en sjølliljestilk. PPL
