The development and quality control of stone wall renovation mortar at Turku Castle

- Short description of the castle and the structures of its outer wall
- The development of the stone wall renovation mortar
- The quality control of the stone wall renovation mortar

Turku Castle

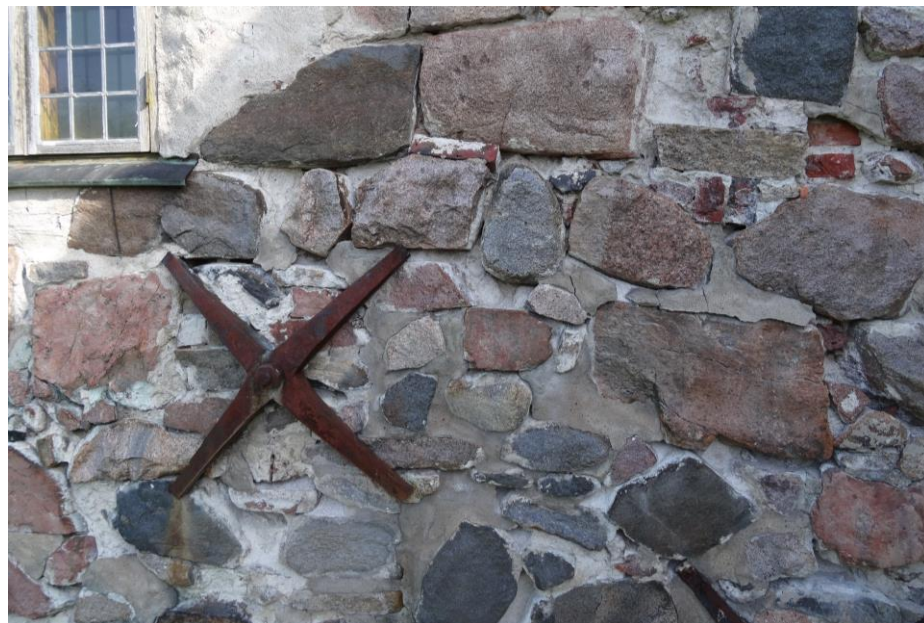
- Located in South-West Finland by the River Aura
- Is constructed of two buildings: the Main Castle (built 1280-) and the Bailey (built 1380-)
 - Multiple periods of construction and renovation
- Lower parts of the Main Castle's outer wall are granite and "cast walls". Upper parts are made of burnt tile and plastered
 - The condition of the outer walls varies from very poor to good (Condition investigation, 2015)
- Several types of mortars different in age and qualities can be found in the outer mortar joints of the granite wall
 - Lime-cement mortar, Parmu masonry cement, hydraulic lime mortar and lime mortar

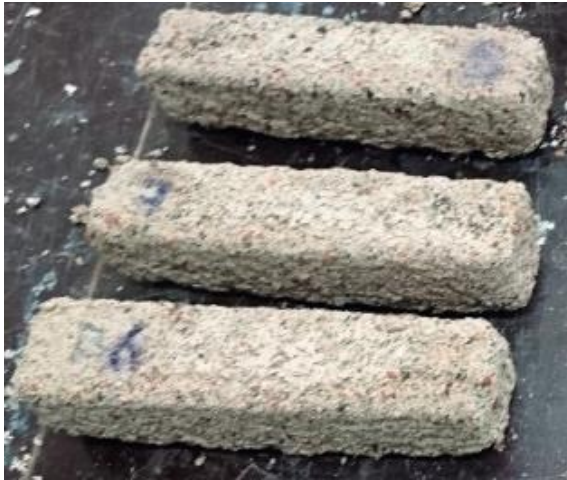
The Olavinlinna reference mortar LLh 15/85/525, after 50 freezing cycles

- Research of the reference mortars (master's thesis, Joonas Lehtonen, 2016)
 - > frost resistance of the reference mortars partly insufficient
- Improving the structure of the protective pores
 - Optimizing the use of air-entrainment agents
 - Checking the distribution and ratio of aggregates
 - > problems in availability
- Minimizing the effect of aggregate distribution
 - Increasing the amount of binder
 - Effects on the shrinking and workability
 - > test renovations on the wall in 2016 and 2017

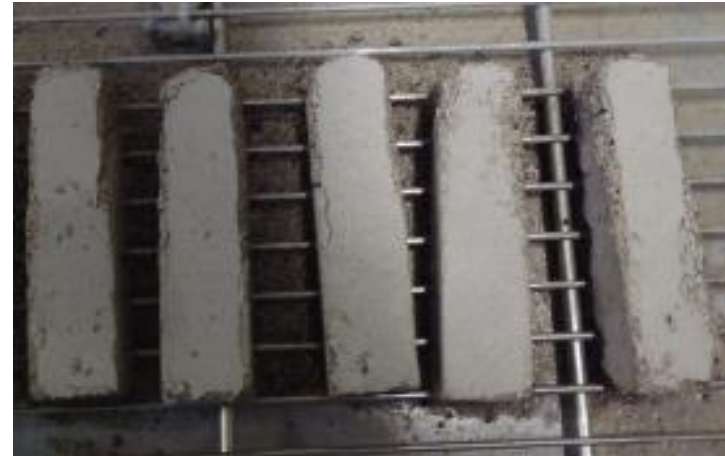
The Turku Castle mortar LLh 15/85/525 + air-entrainment agent, after 25 freezing cycles

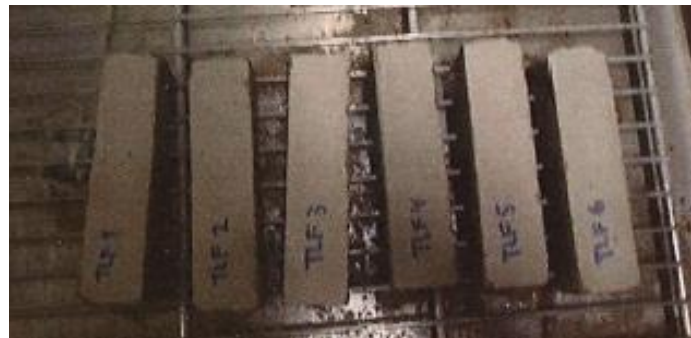
The Turku Castle mortar LLh 15/85/440 + air-entrainment agent, after 100 freezing cycles

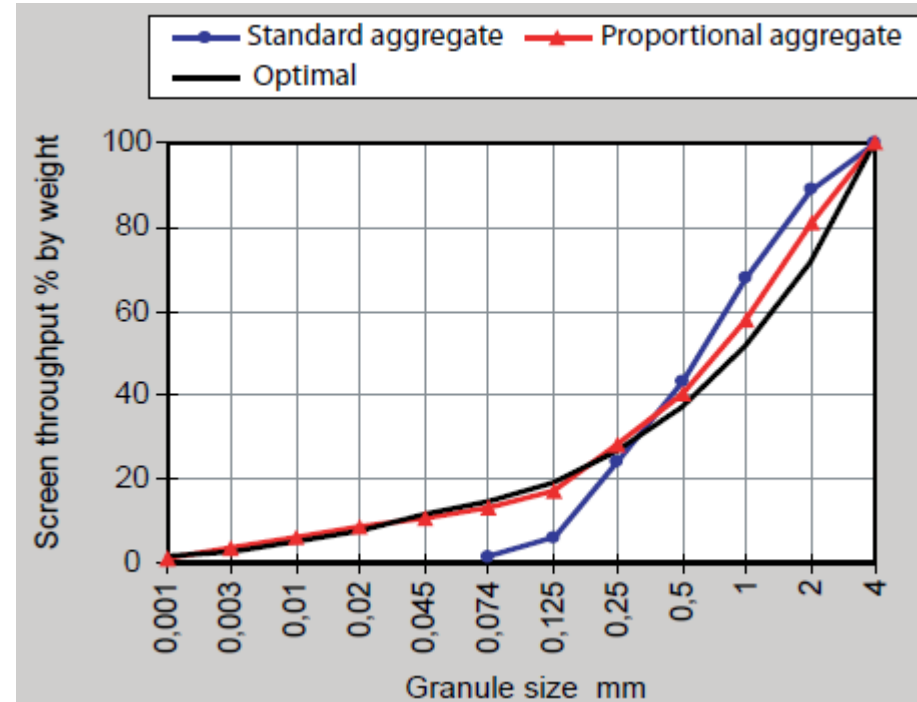
- Sieving the grain size distribution of the aggregate (Tampere University)
 - Every new batch of aggregate ordered
 - Comparing to aggregate distributions already proven to be functional and to the optimal distribution (von Konow)
 - Fine tuning the mixture ratios of the aggregate when necessary.

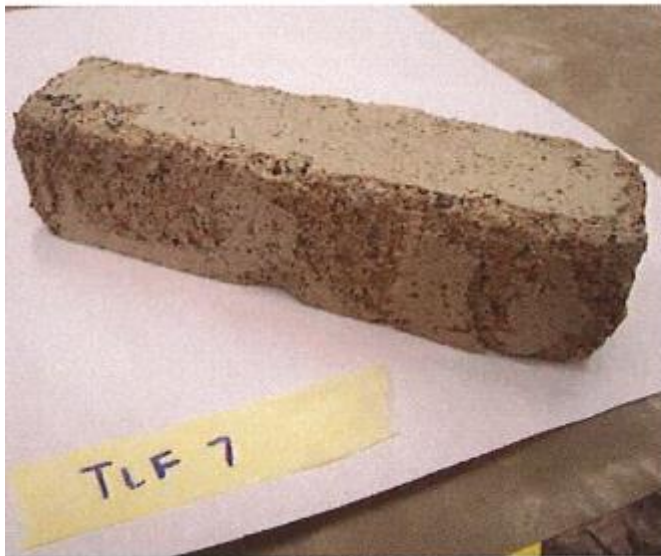
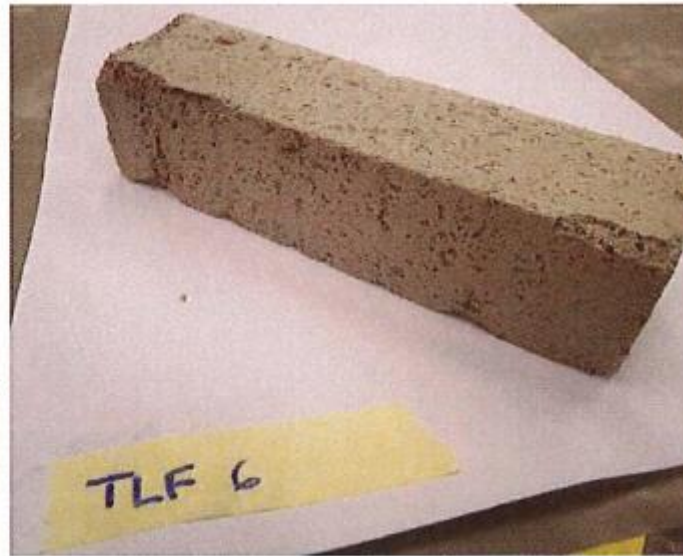
Bending strength Compression strength

- Freeze-thaw test of the mortar samples (SFS 5447)
 - For every new aggregate batch after grain size distribution check
 - Quick-carbonatizing (Tampere University)
 - Decrease on bending strength < 33 % after 100 cycles
 - Protective pore ratio > 0,20
- (Thin section analysis from hardened mortar from the stone wall if necessary)

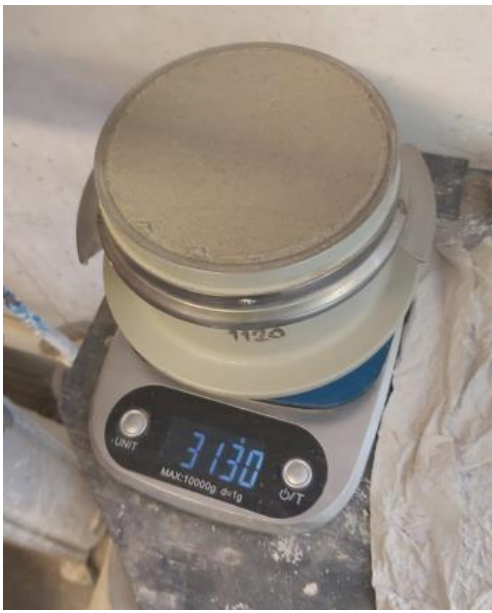
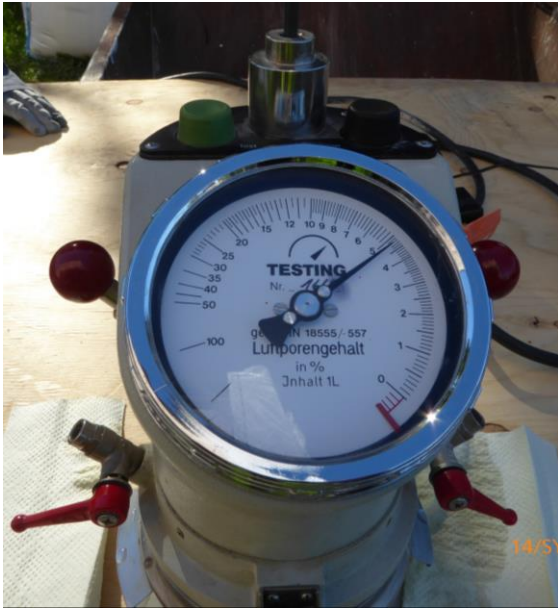
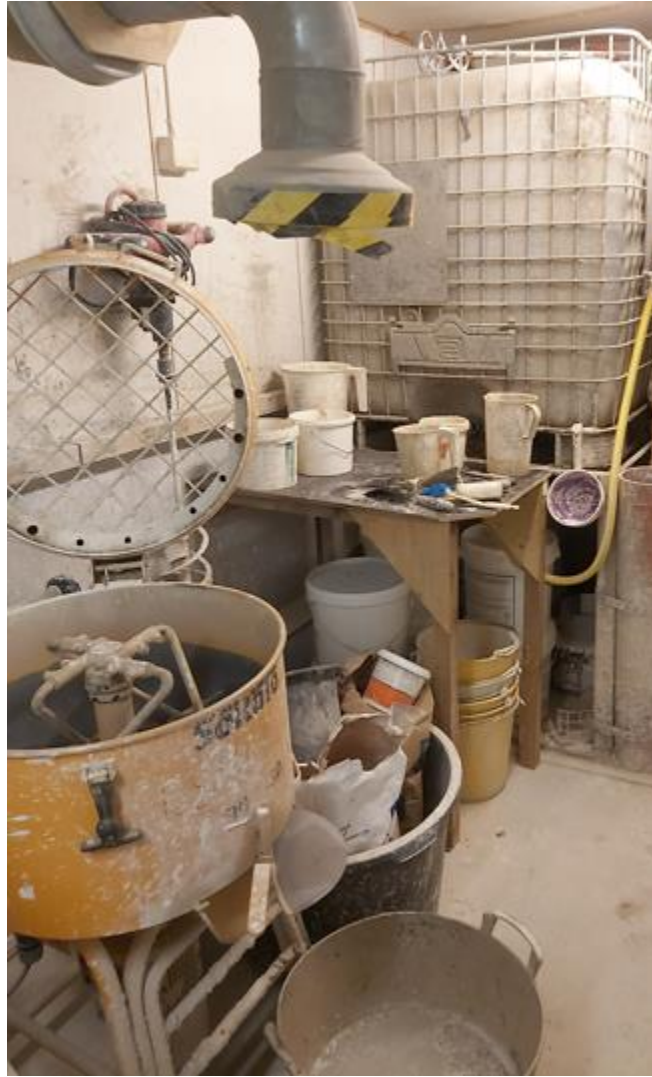
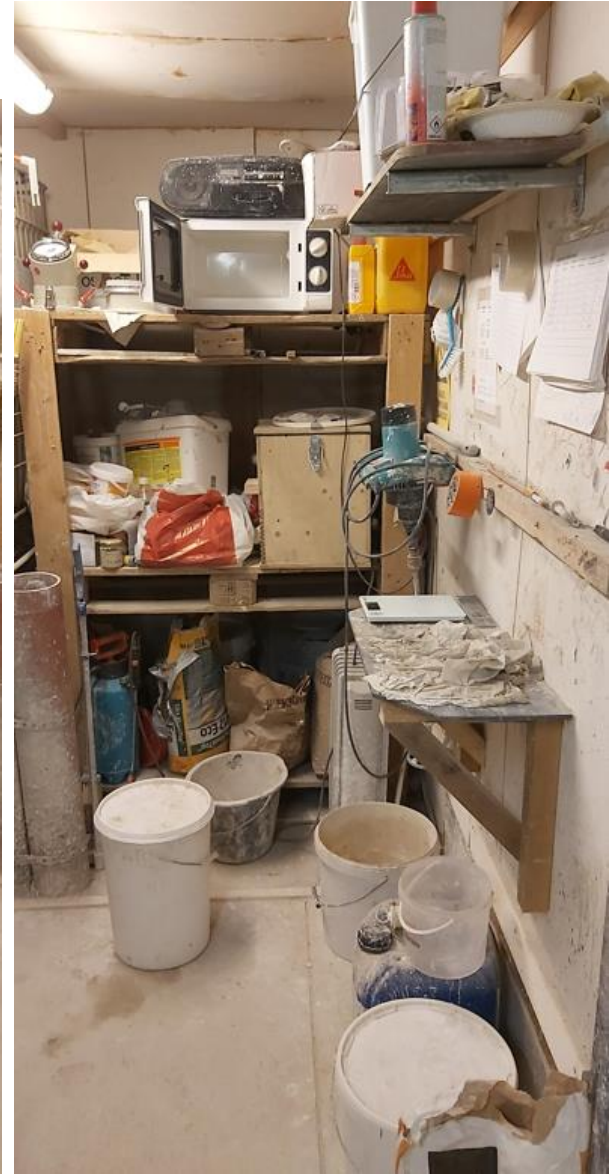
- Measurements of fresh mortar
 - Air-entrainment (10 %), water-entrainment (14 %), density -> indicators
 - Weekly from the first batch of mortar
- ("Home-made" freeze-thaw tests of the mortar samples)

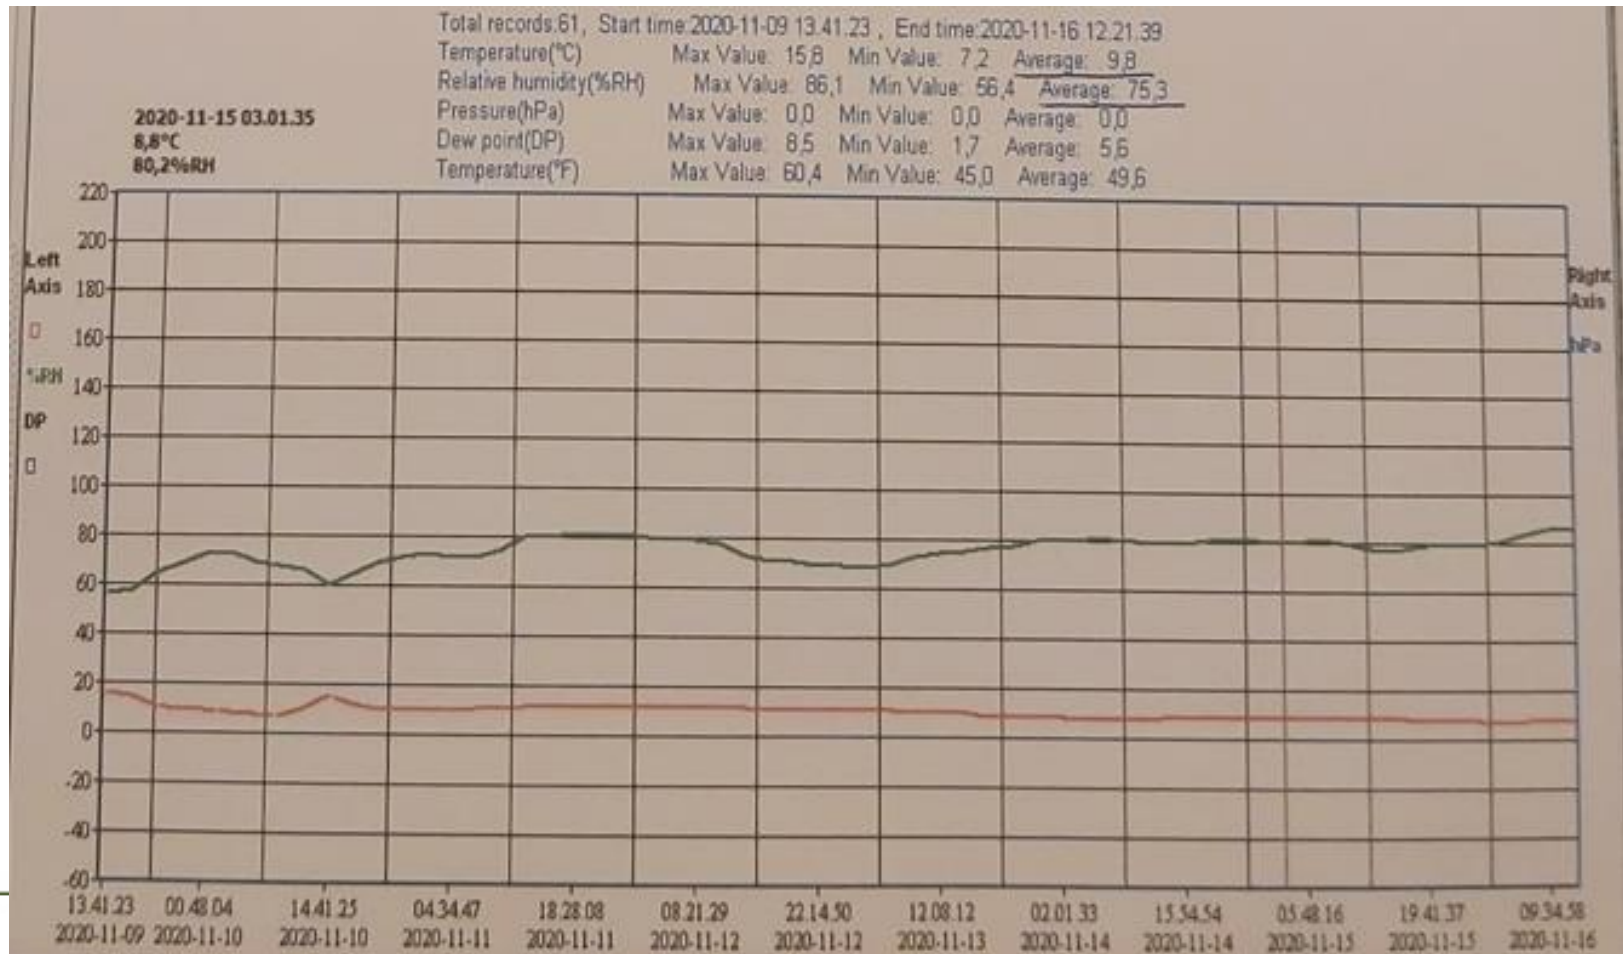
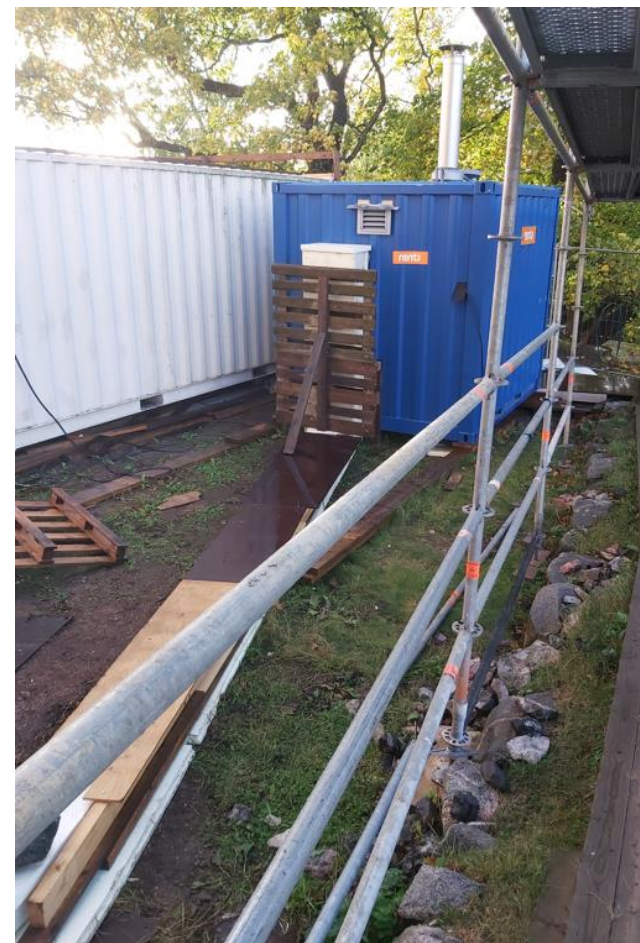
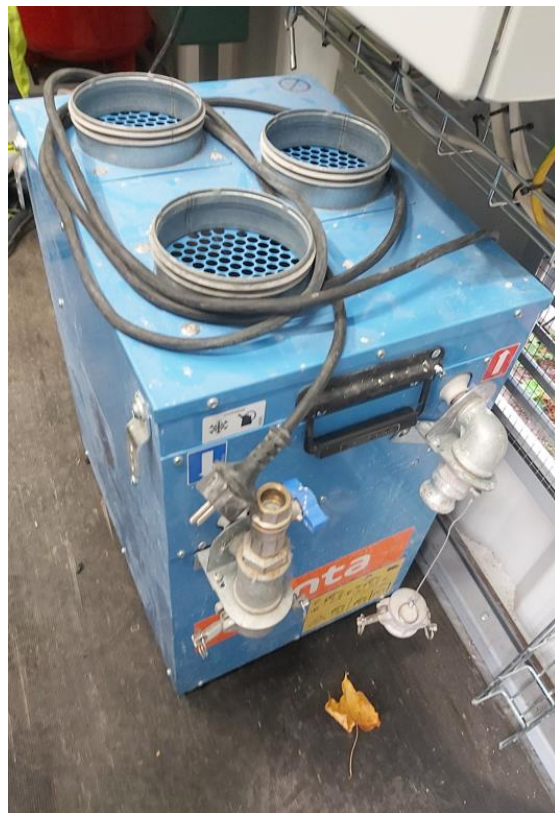
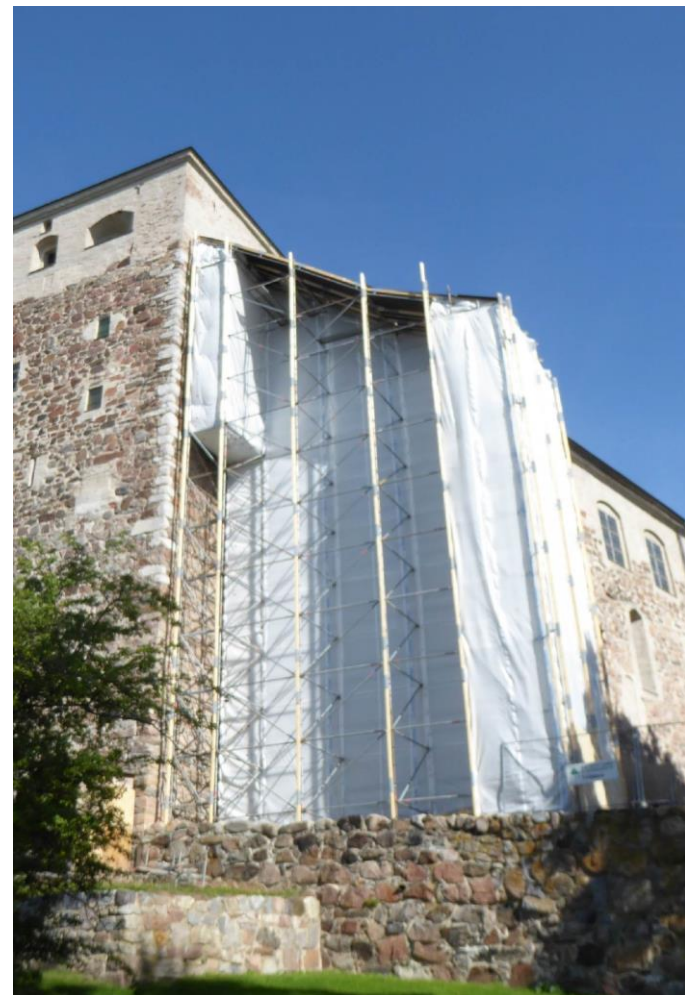
- Monitoring conditions
 - Constant monitoring of temperature and relative humidity
 - Working in winter -> stability on the conditions
- Visual inspection of the mortar joints and the wall surface post-aftercare
